STRING ASSEMBLY & LESSONS LEARNED

Mathieu Therasse BE-RF/SRF

7th HL-LHC Collaboration Meeting, Madrid, 13–16 Nov 2017

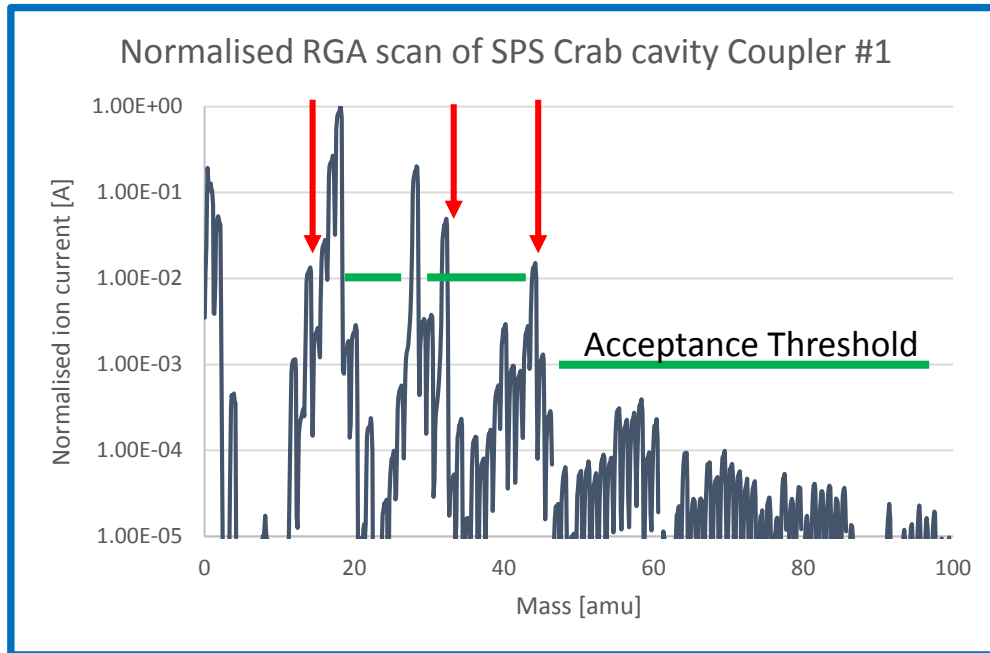
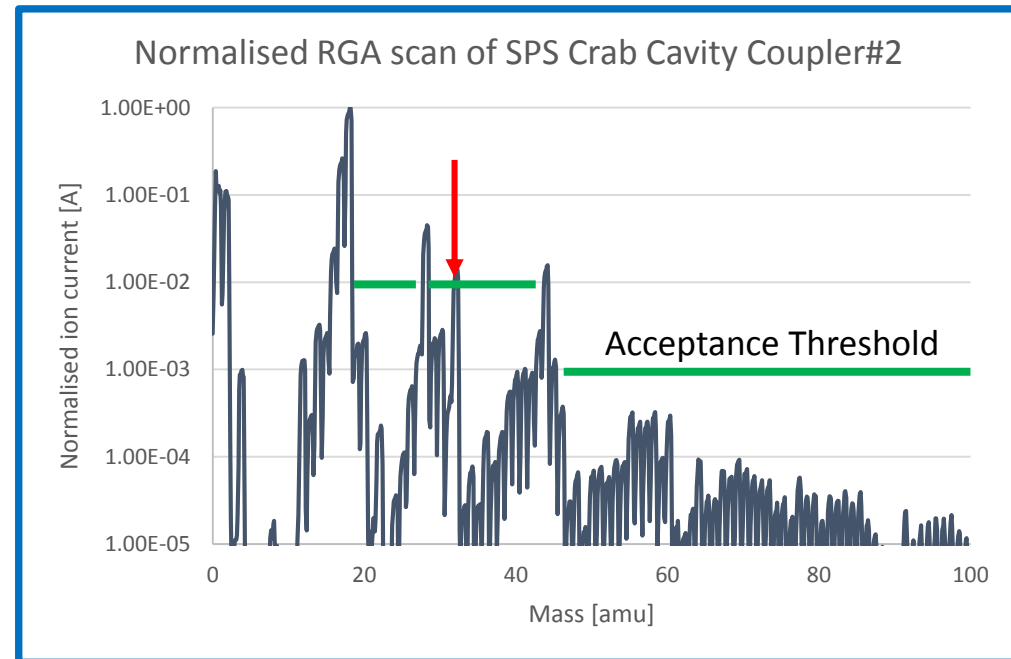
Air leak on Coupler 1, leak detection showed the leak was on the DN16CF flange of the vacuum chamber

Peak 32 is a characteristic of W filament RGA

No contamination

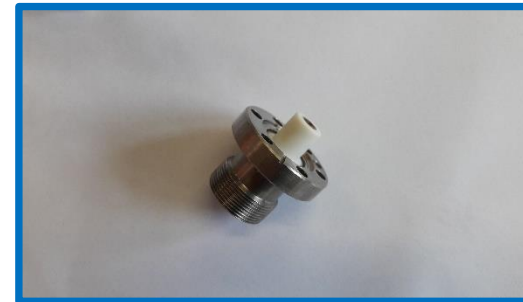
HOMs feedthrough changing week 28-29

Issue

Leak on the feedthrough ceramics during the RF cold test of the partially dressed Crab 1 (cf A. Castilla talk)
Little time to find and make new feedthrough

Thermal shocked
Leak tight

RF feedthrough (7/16) used for LHC
PMB Alcen
Manufacture of new antennas
Limited power to 200W max

Replacement of the feedthrough on Crab 1
Preparation and mounting of the new feedthrough on Crab2

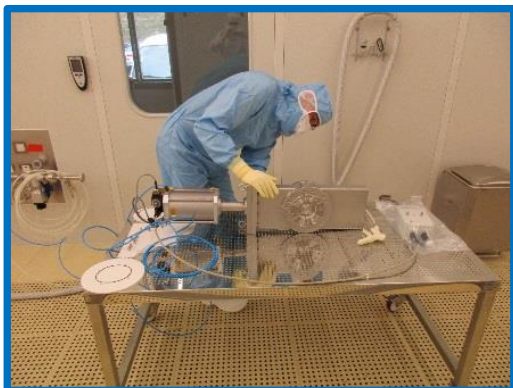
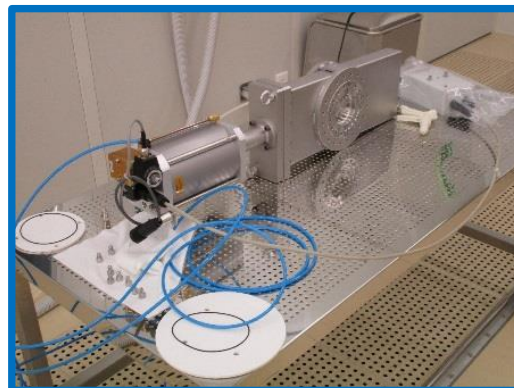
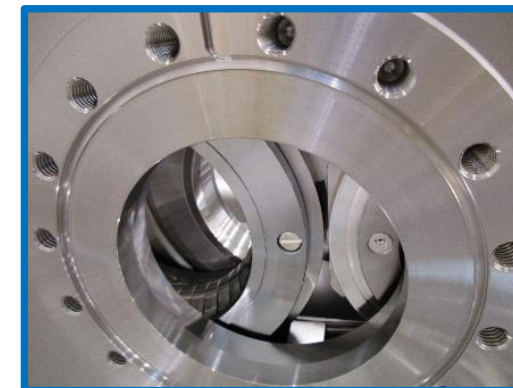
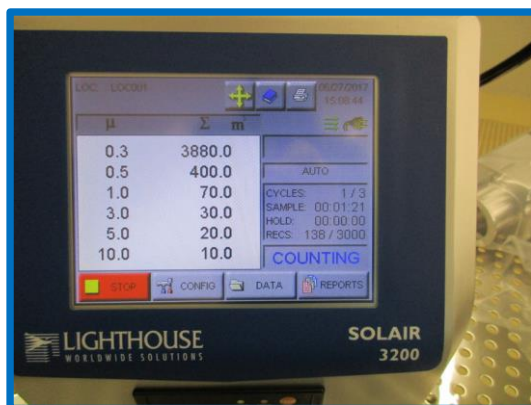
Cleaning Process

Issue

After cleaning particle number is in the ISO4 threshold

After opening and closing cycles \longrightarrow particle production

We can't assure the cleanliness after using the valve

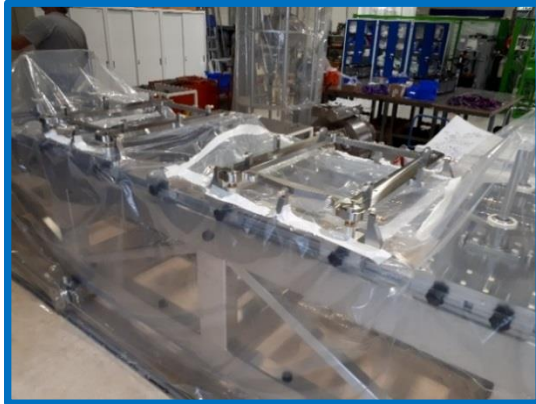
Issue

Cavity Lifter not well adapted : impossibility to put the cavities on the trolley

Cavities and trolley protected with plastic bag

Do the installation outside the cleanroom by using the crane

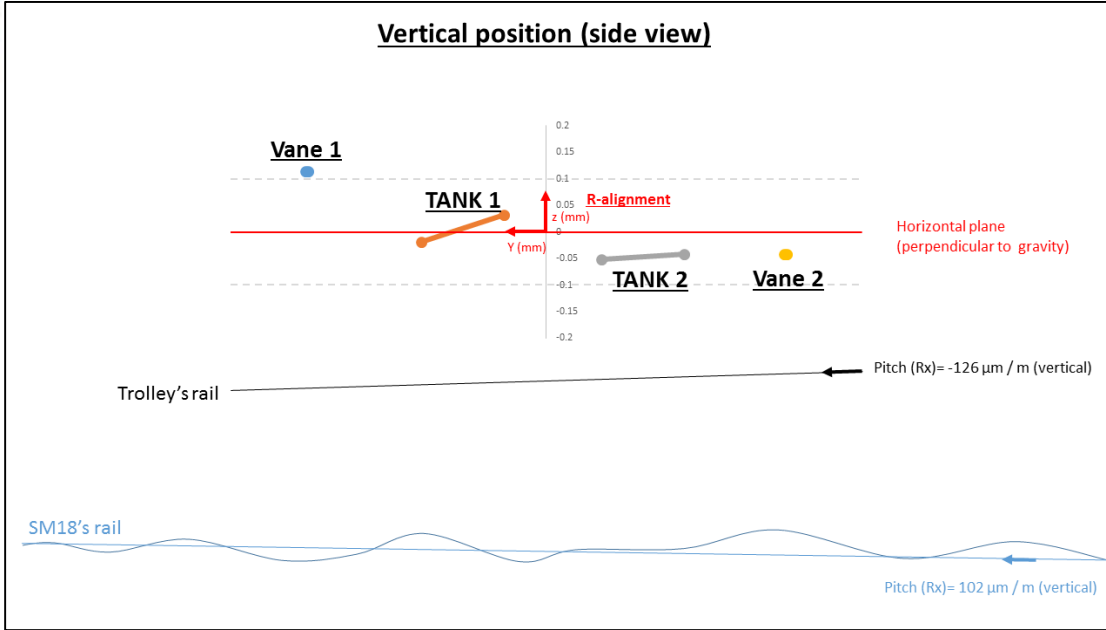
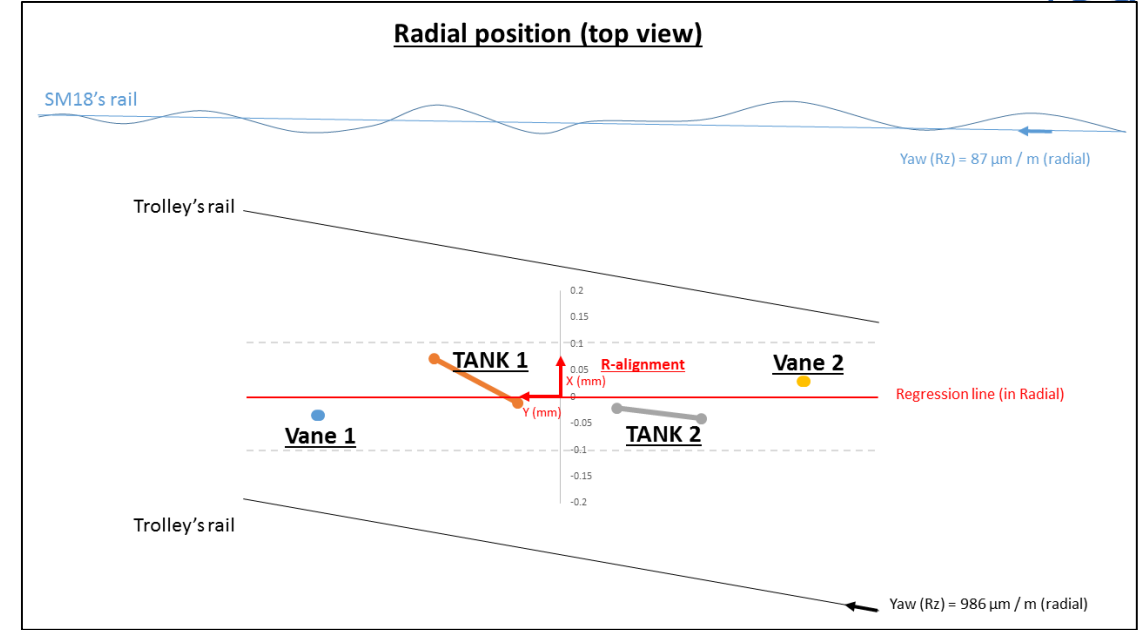
String cavity alignment before connection

3D-rotation compared to the nominal angle

All components aligned at 115 μm

Components aligned with a regression line of the 4 components at 70 μm

2 tanks: differences below 200 μrad

2 valves : A maximum of 700 μrad in Ry

Not perfect but acceptable for the components connection

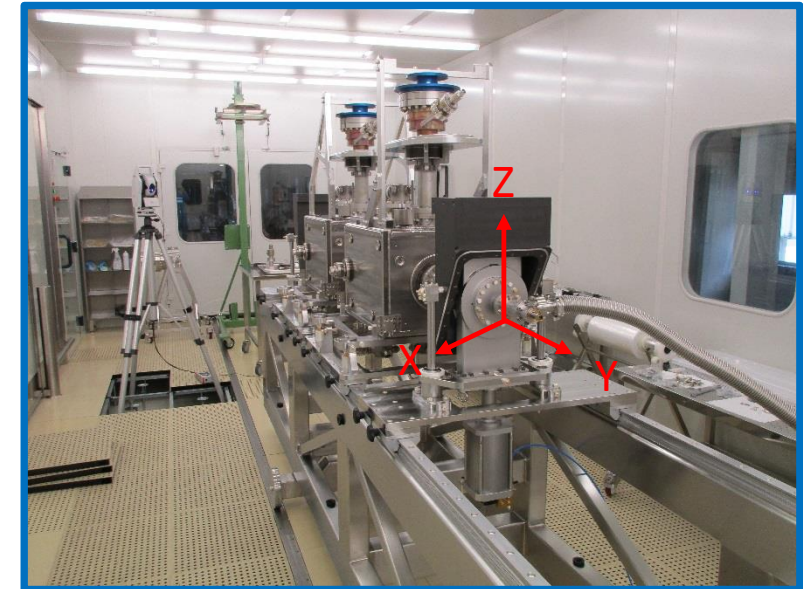
The displacement of all the components follows the theoretical displacement (trolley's rails trajectory)

All components aligned at **130 μm**

Components aligned with a regression line of the 4 components at **230 μm**

2 valves : Some rotation higher than **1 mrad on Rx**

Both valves : vacuum impact the pitch rotation Rx

A new alignment should be done to be below 100 μm

The 2 valves Rx rotation should be corrected
