STRING ASSEMBLY & LESSONS LEARNED

Mathieu Therasse BE-RF/SRF

7th HL-LHC Collaboration Meeting, Madrid, 13–16 Nov 2017

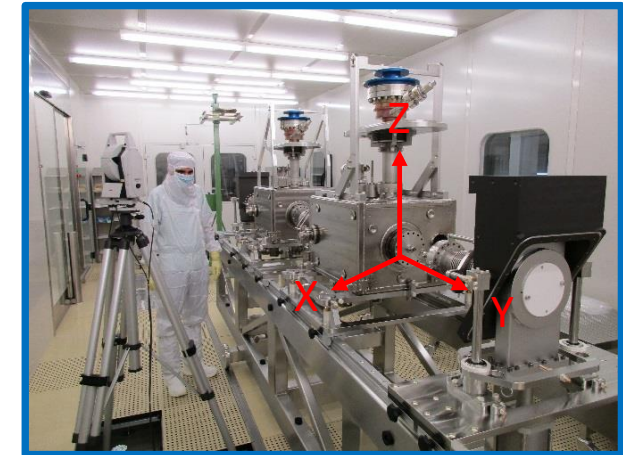
Survey done inside the cleanroom

Alignment reference chosen: cleanroom's rail

Pb: Non-parallelism between SM18's rail and trolley's rails

Due to lack of time we continued with the SM18's rail

The string had to be realigned outside the cleanroom after connection for cryostating
