STRING ASSEMBLY & LESSONS LEARNED

Mathieu Therasse BE-RF/SRF

7th HL-LHC Collaboration Meeting, Madrid, 13–16 Nov 2017

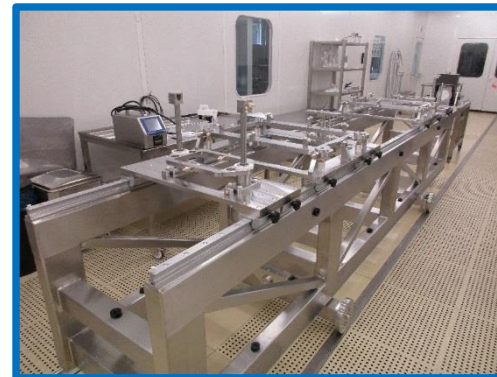
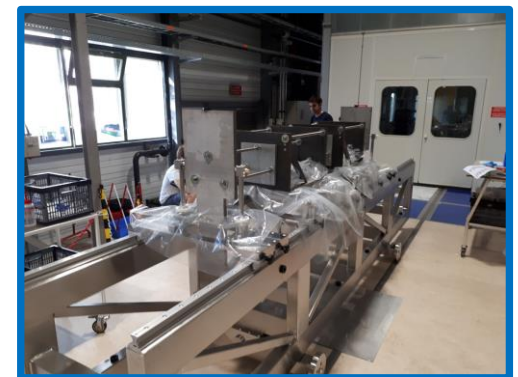
Cavity trolley (week 30)

Load test did not show deformation
Alignment system for valve has to be improved

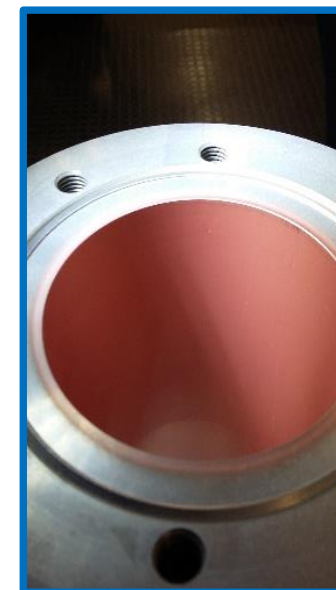
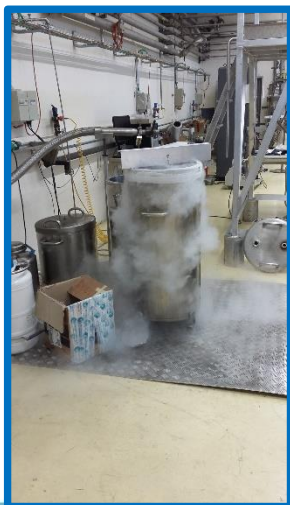
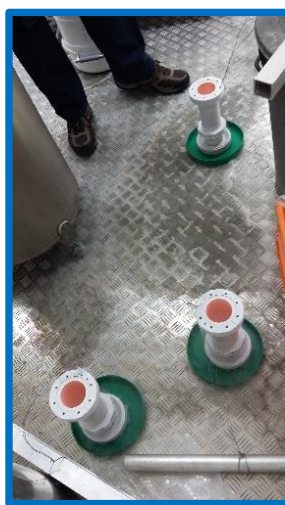
Cu layer Coating

- Sputtering process (end of June 2017)

→ peel off

- Galvanic surface treatment (mid of July 2017)

Au layer of 2 μm as buffer layer

Cu layer of 10 μm

Passivation (Sulfo-chromic bath)

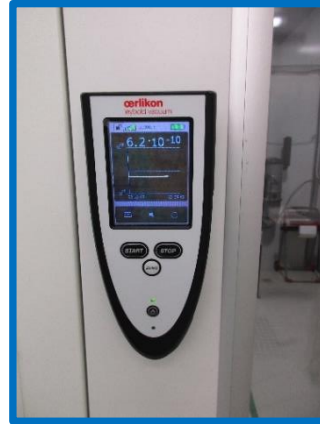
Leak tight

Leak rate: 6×10^{-10} mbar l/s

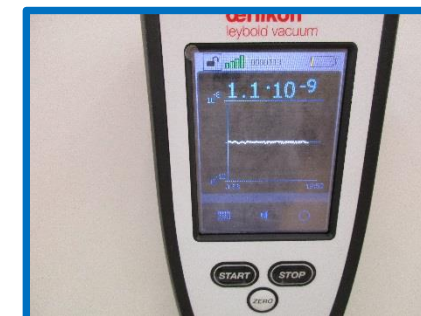
HOMs feedthrough changing week 28-29

Issue

Leak on the feedthrough ceramics during the RF cold test of the partially dressed Crab 1 (cf A. Castilla talk)
Little time to find and make new feedthrough

Solution

RF feedthrough (7/16) used for LHC
PMB Alcen
Manufacture of new antennas
Limited power to 200W max

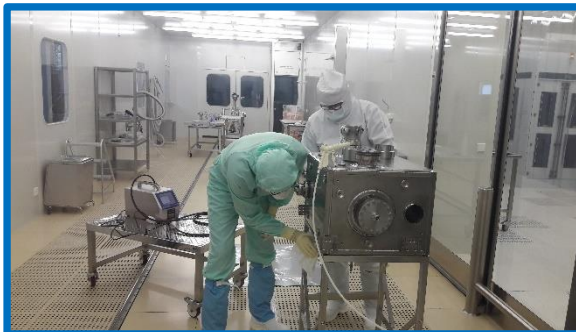
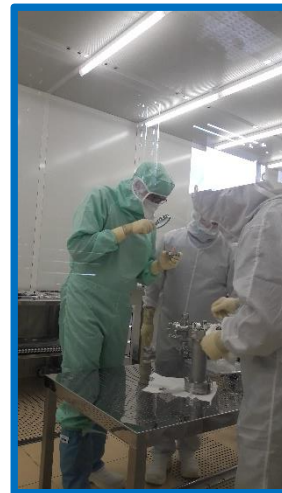
Thermal shocked
Leak tight

Actions

Replacement of the feedthrough on Crab 1
Preparation and mounting of the new feedthrough on Crab2

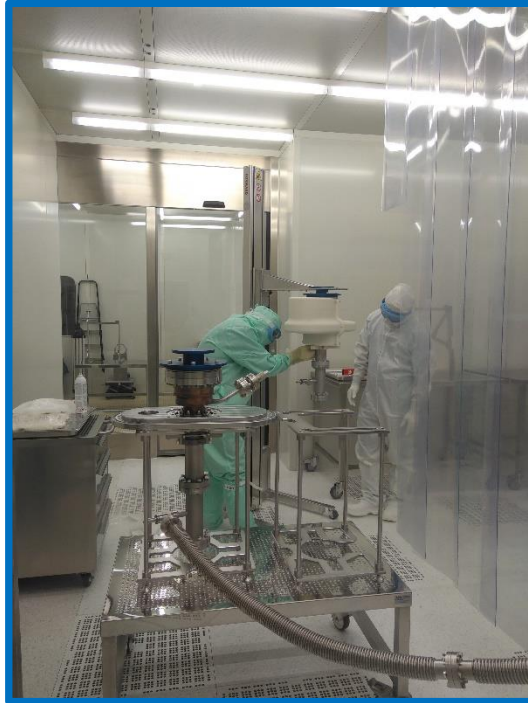
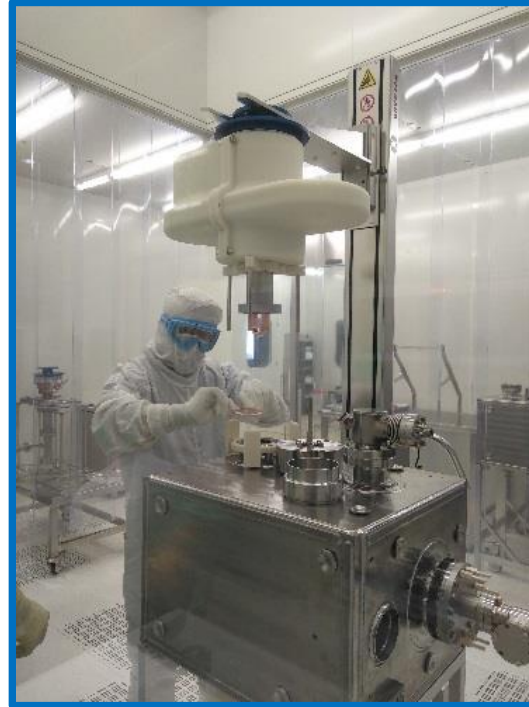
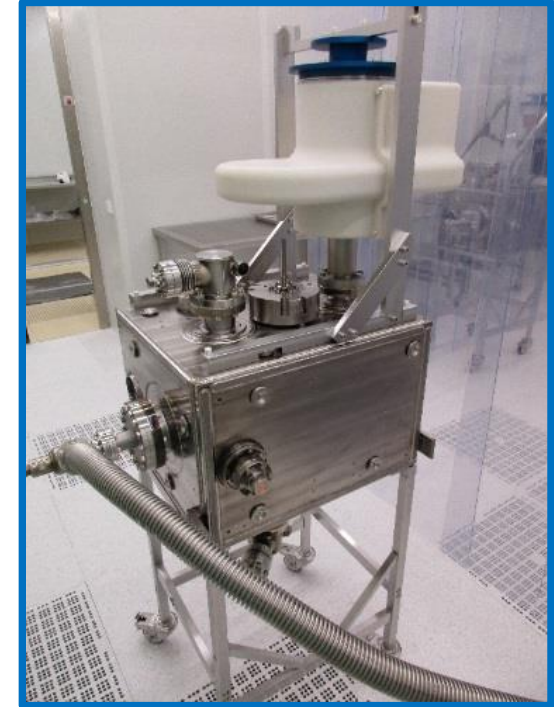
Mounting done without N₂ gas flushing

Very sensitive handling

Risk to touch the cavity with the FPC antenna
Metallic particles production

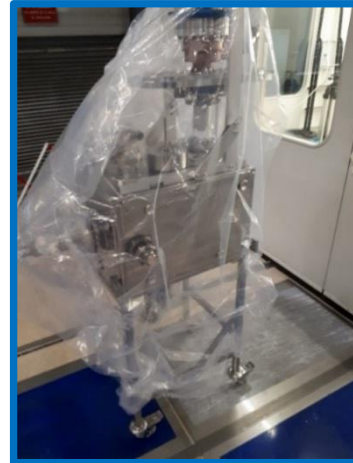
Issue

Cavity Lifter not well adapted : impossibility to put the cavities on the trolley

Solution (no choice)

Cavities and trolley protected with plastic bag

Do the installation outside the cleanroom by using the crane

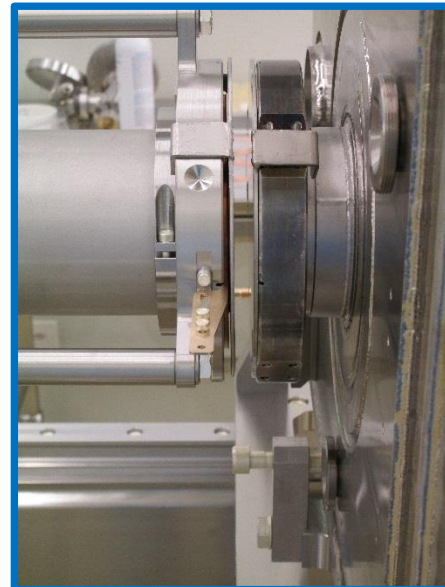
Connection done without N₂ gas flushing
